# Parking Lot Ponding and Erosion

Zach Primm, 4/26/16, BE 3220

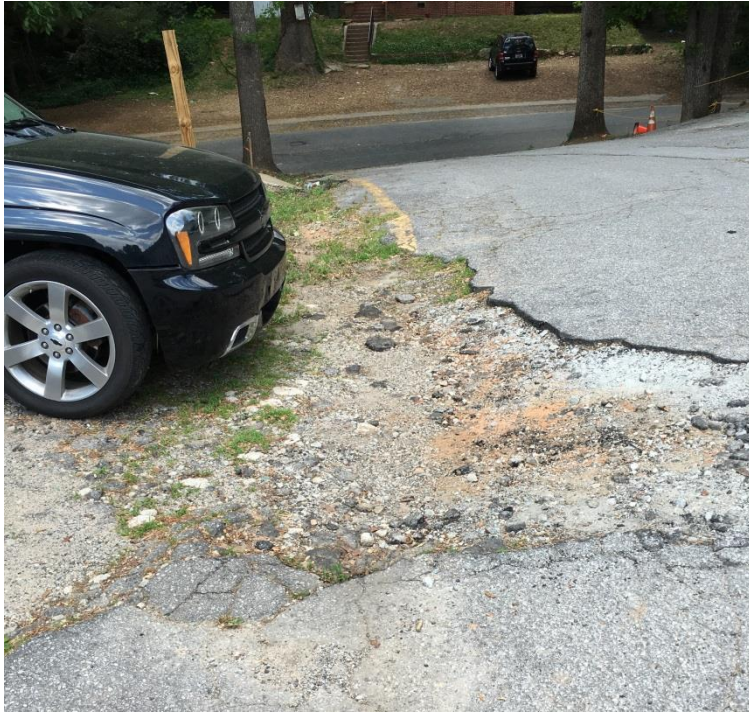
An additional principle is infiltration but the majority of the parking lot is cement so there is none. However on the west side of where the ponding section eventually drains, when the water level is high enough, in the north west corner of the parking lot, there is no asphalt allowing for Infiltration of the water that then potentially flows under the asphalt causing the severe erosion seen in figure 2 on the next page.

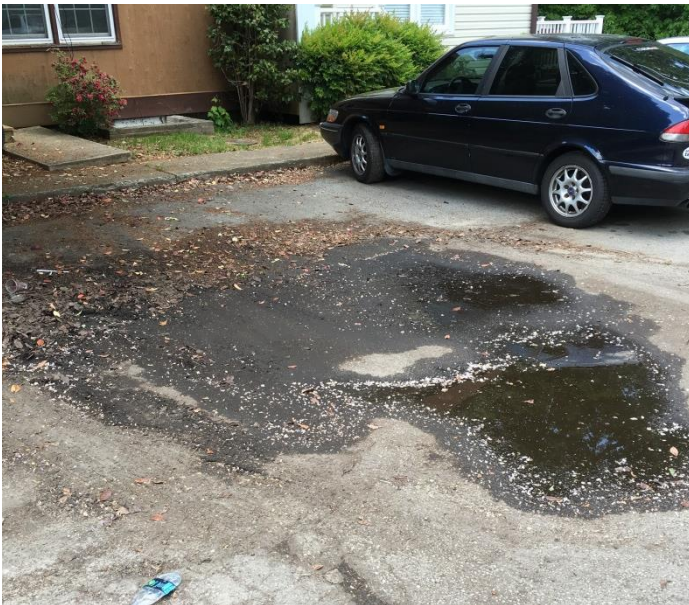
There was not enough acquired data to determine the ponding time of the ponding section however Figure 1 below depicts the section four days after the most recent rain with water still waiting to be evaporated as there is no other exit.

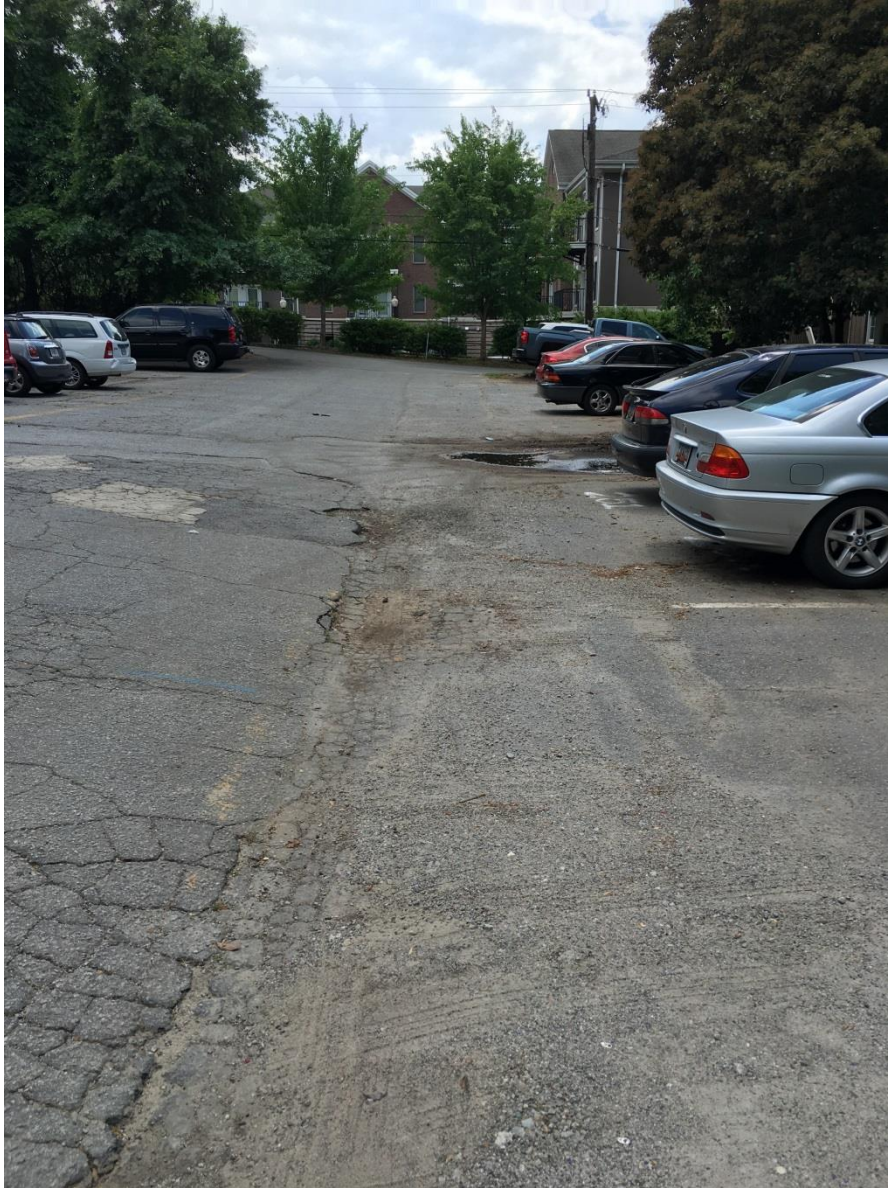
View of "channel"

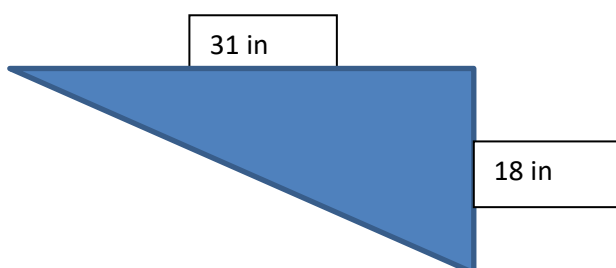
Triangle used to find slope of steepest East to West sloped point
